Maine Department of
Transportation
**Transportation Research
Division**

Technical Report 97-20

*Subsurface Drainage for Rehabilitation of PCC
Pavement – Rt. 202 Gray – New Gloucester*

Final Report, December 2003

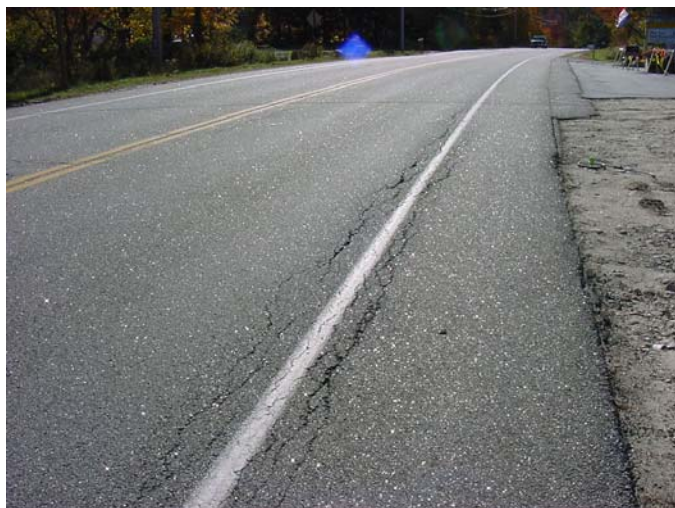
Photo 1. Area 3 PCC Related Edge Cracking

The length of PCC related edge cracking in Area 3 has increased dramatically from a total length of 5.3 m (17 ft) in 2001 to 28 m (92 ft) in 2002, an increase of 428% (Photo 1).

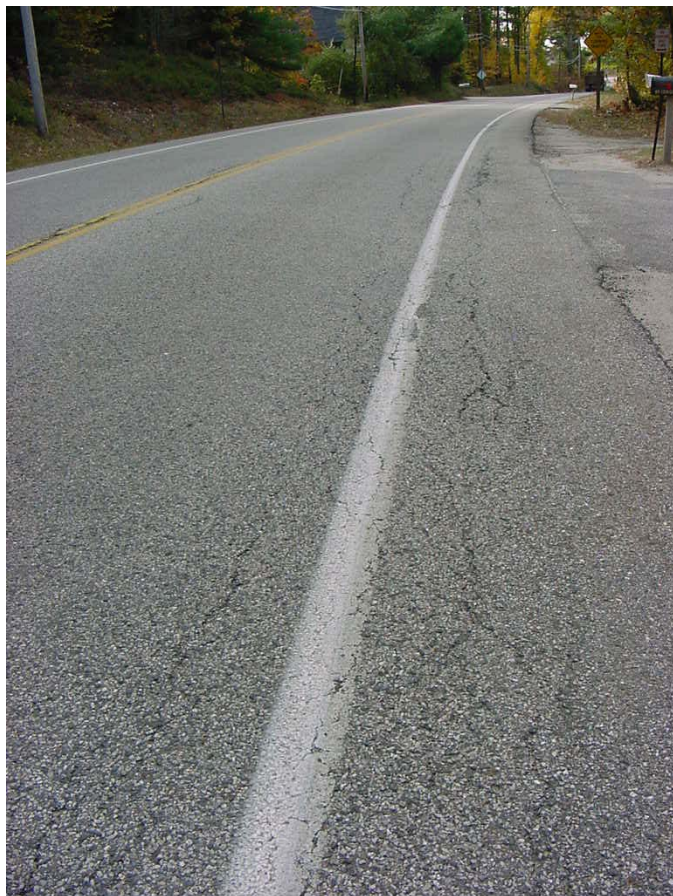
Photo 2. Area 4 PCC Related Edge Cracking

Area 4 PCC edge cracking increased 72% from a length of 12.2 m (40 ft) to 21 m (69 ft) in 2002 (Photo 2).

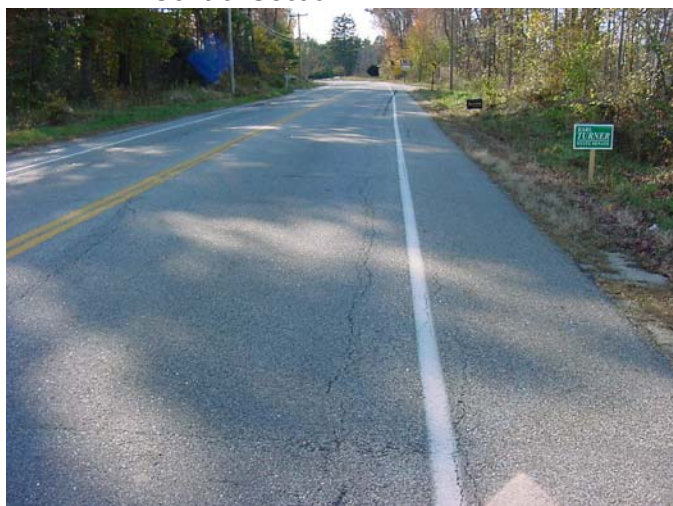
Photo 3. Control PCC Related Edge Cracking

In the Control Section, PCC related edge cracking increased 11% from a length of 133.1 m (437 ft) in 2001 to 148 m (486 ft) in 2002 (Photo 3).

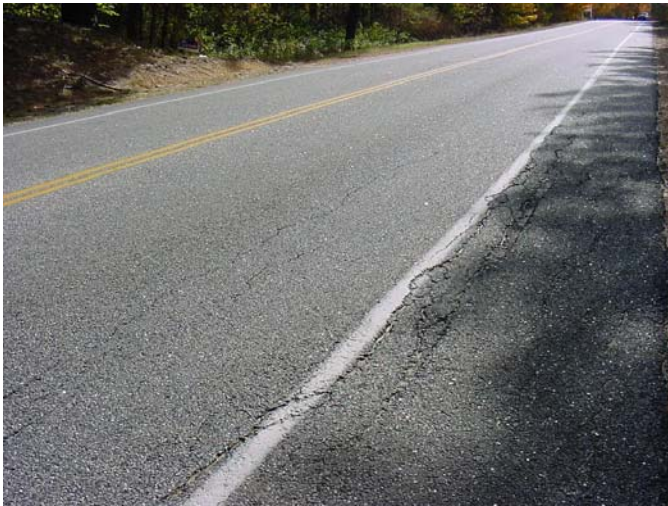
Photo 4. Area 1 Cracking

Edge of pavement or shoulder cracking has increased 333% from a total length of 26.1 m (86 ft) to 113 m (371 ft) (Photo 4).

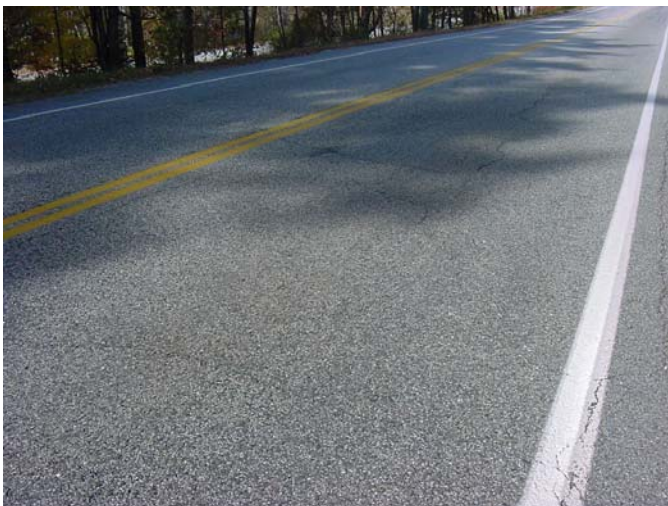
Photo 5. Area 2 Cracking

Cracking between the wheel paths has increased slightly from a length of 40 m (131 ft) to 42 m (138 ft), an increase of 5% (Photo 5).

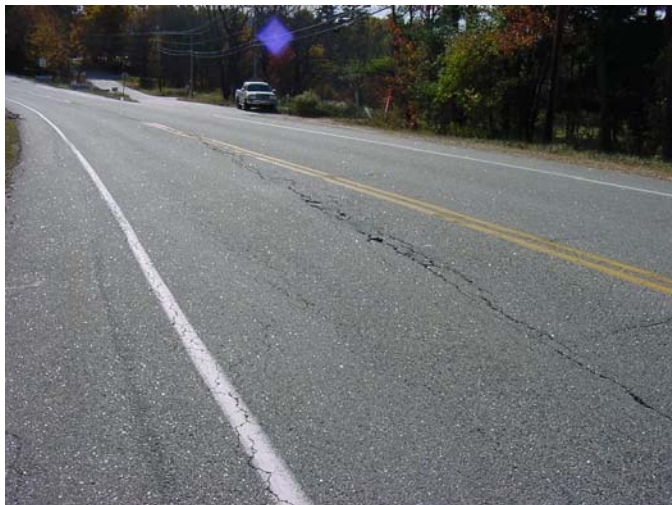
Photo 6. Area 4C PCC Edge Reflective Crack

Area 4C has 19.7 m (65 ft) of PCC running under the roadway. All of it is skewed across the lane due to realignment of the road as can be seen in Photo 6. The original composite road is where the truck is parked and you can see where the PCC pavement edge crack lines up with the edge of the original road. Although Area 4C has PCC under the roadway it is not included in the Composite Roadway Group because the PCC offset is great enough that the experimental drainage would have no influence on this section of road.

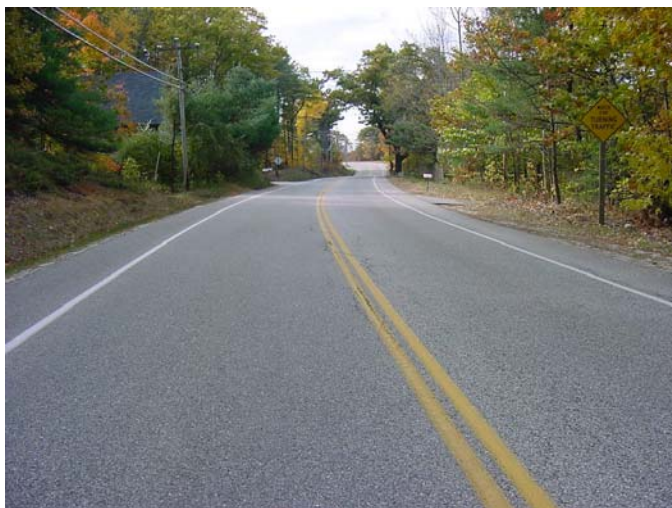
Photo 7. Area 5 (Left Lane)

Area 5 has a slight increase in centerline separation from 103.1 to 107 meters (338 to 351 feet). Forty seven meters of this cracking is greater than 25 mm (1 in) in width (Photo 7).

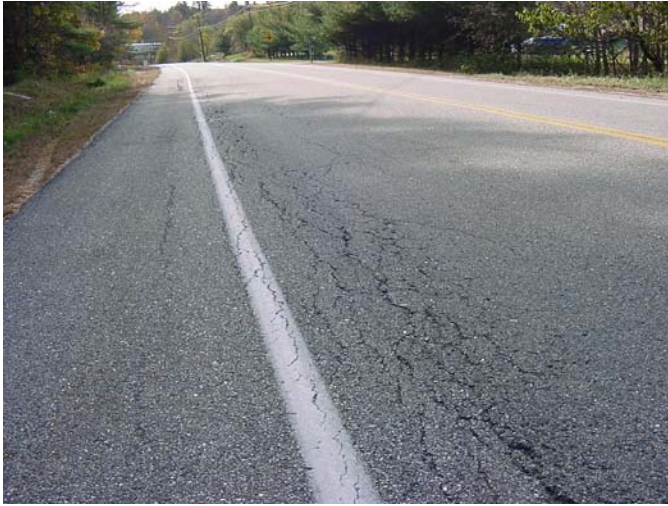
Photo 8. Control 2 Cracking

Load cracking has increased 22% from a total area of 189.9 m² to 231 m² (2044 ft² to 2486 ft²) (Photo 8)
